State of Wisconsin International Charter and EagleVision Report of the June 2008 Midwest Floods

October 2008

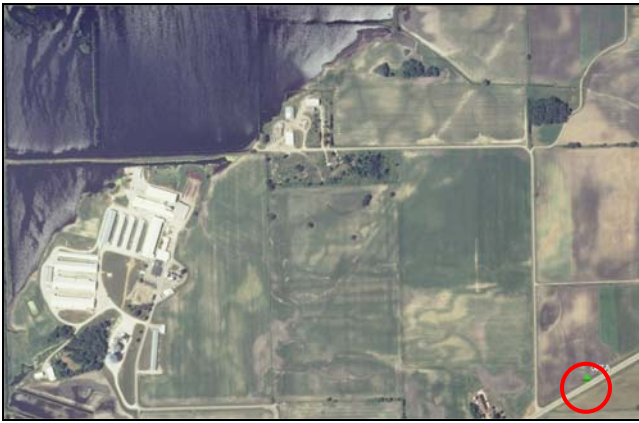
7/5/2008 NAIP Air Photo (1m)

The ground truth aerial photography and GPS data provided an opportunity to compare satellite imagery analysis with more detailed imagery and on the ground information. The date of the 2008 NAIP imagery was July 5, 9, and 23, significantly after the main flooding event. However, it is possible to discern in the imagery areas where water stood prior to draining. In the examples provided here, the SPOT-4 imagery seems to correspond most accurately to the aerial imagery and ground truth GPS observations.

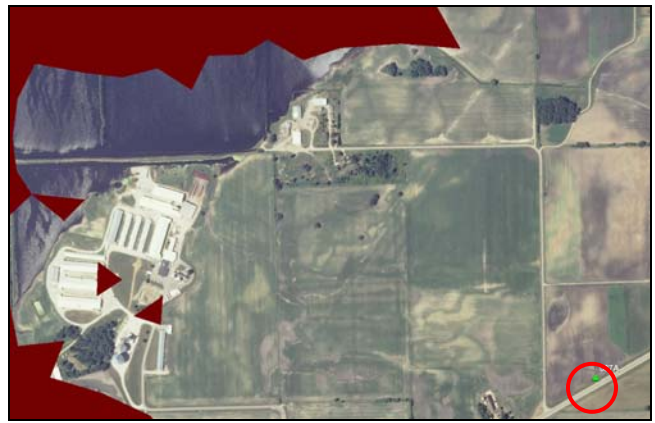
Water from Landsat 6/18/2008 (30m)

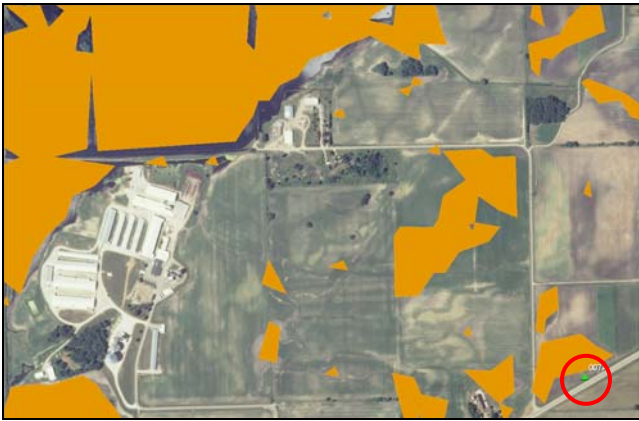
Water from SPOT-4 6/14/2008 (20m)

The GPS team documented standing water at site 007A. Only the RADARSAT and SPOT-4 imagery captured the standing water.

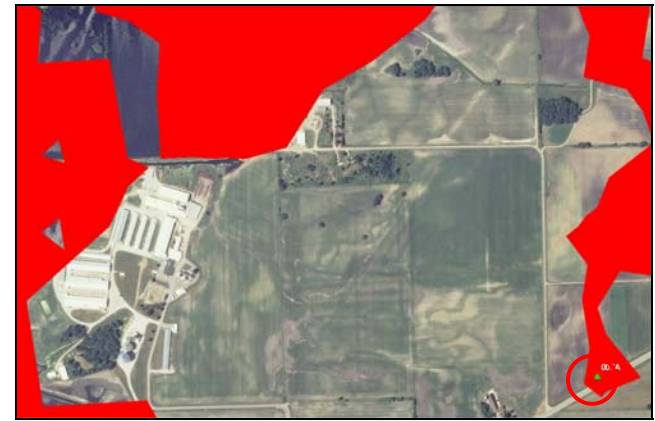
Water from RADARSAT-1 6/16/2008 (25m)

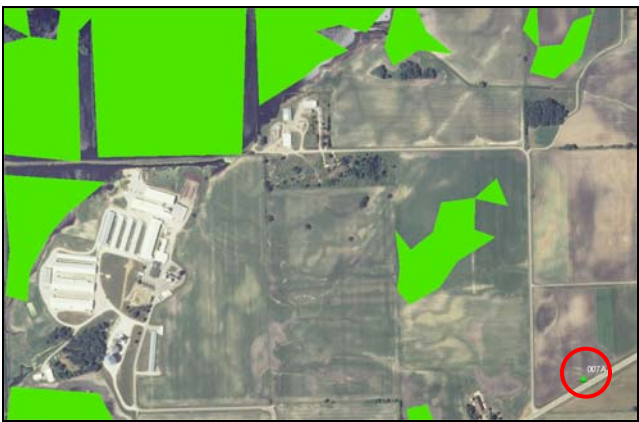
Water from SPOT-2 6/14/2008 (20m)

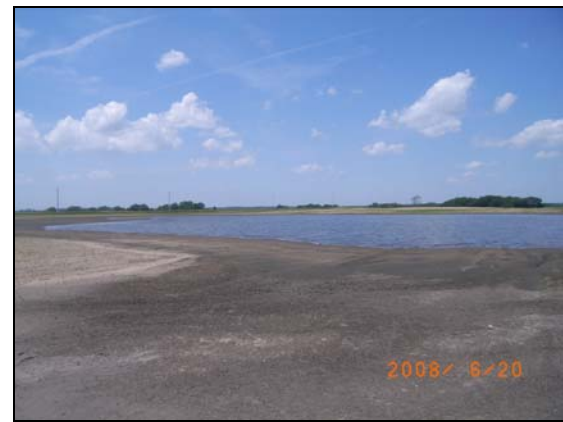
View north from 007A (marked with red circle)
